AUDIT OF RIVER MANAGEMENT ASSET MAINTENANCE STANDARDS

- Audit of:** River Schemes managed by the Flood Protection Department, Landcare Division of the Greater Wellington Regional Council
- Audit by:** Michael Hewison, Mike Longworth and Maia Kawana of the Operations Department Wairarapa Division, Greater Wellington Regional Council
- Locations:** Wainuiomata River and Porirua Stream
- Guides:** Jeff Evans, Mike Jensen & Jacky Cox of the Flood Protection Department, Landcare Division, Wellington Regional Council
- Date:** 19 July 2005

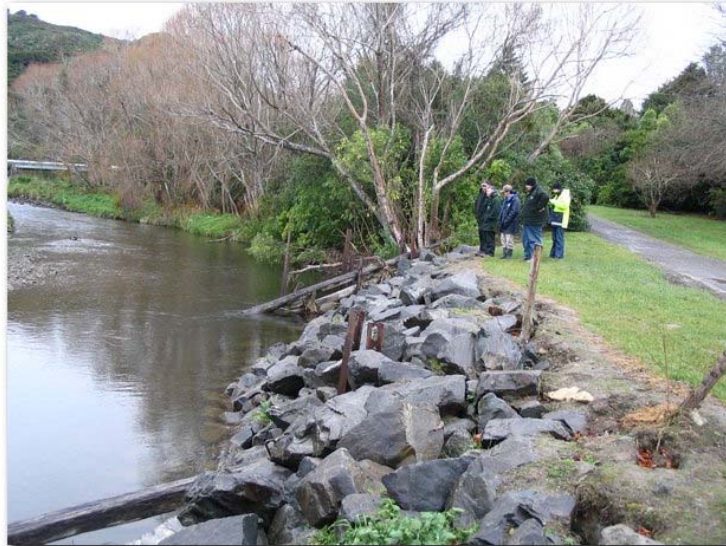
Figure 1 Poole Cres Rockline Looking upstream

The rock rip rap has provided a good long term solution to protecting this sharp right hand bend. The older rail and timber pole groynes could have some of the rail irons cut down so as not to extend excessively above the top horizontal. The reviewers concur with protective works adopted for this site. The combination of new protection works and existing

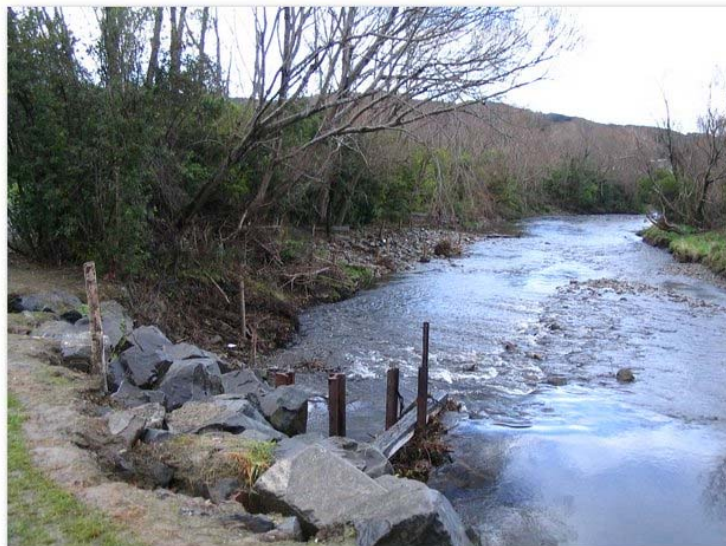
Figure 2 Poole Cres Rockline Looking downstream

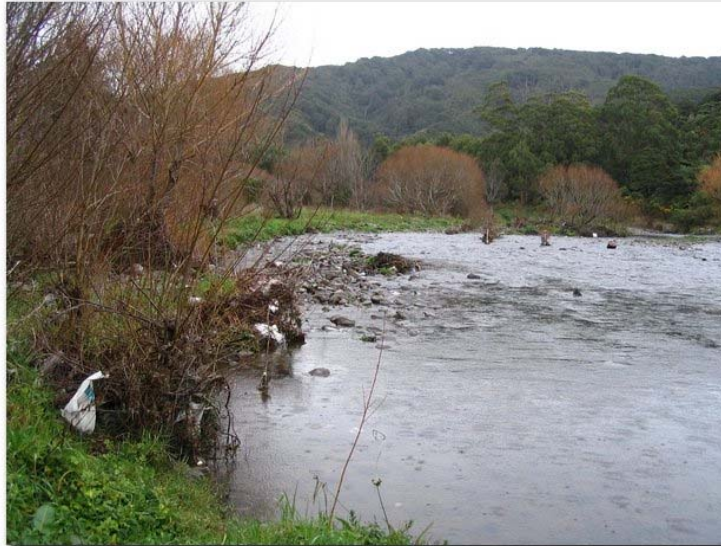
The right hand bend down stream of the Faulkes property has suffered significant erosion of the left bank with earlier willow pole planting being out flanked and the river now being over wide. The proposed works being considered are a series of short debris fences on the outside of the bend and removing the beach and high inside corner on the inside of the bend. Many of the willow trees protecting the banks were washed out in the 2004 floods.

Figure 3 Looking Downstream - out flanked poles and over wide bed

The reviewers would agree with the proposed method of reinstating this bend. The design of this work would definitely benefit from having a design channel alignment available on this river. It is understood that the budget for repair work on this bend is in the order of \$10,000 which is unlikely to be sufficient.

- Developing the design channel alignment for the Wainuiomata River.
- Continue to monitor the toe of the Porirua Stream at Wall Place to ensure the minor bank toe erosion does not increase in scale.

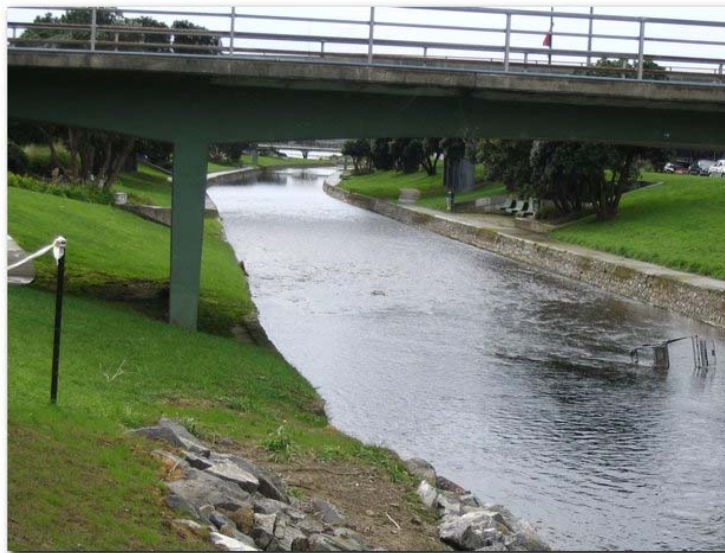
Figure 4 Cleaned out stream looking downstream

The reviewers were of the opinion that the channel capacity had been effectively restored in what were obviously difficult operating conditions. The flood wall and the general area appeared in good condition and were being well maintained.

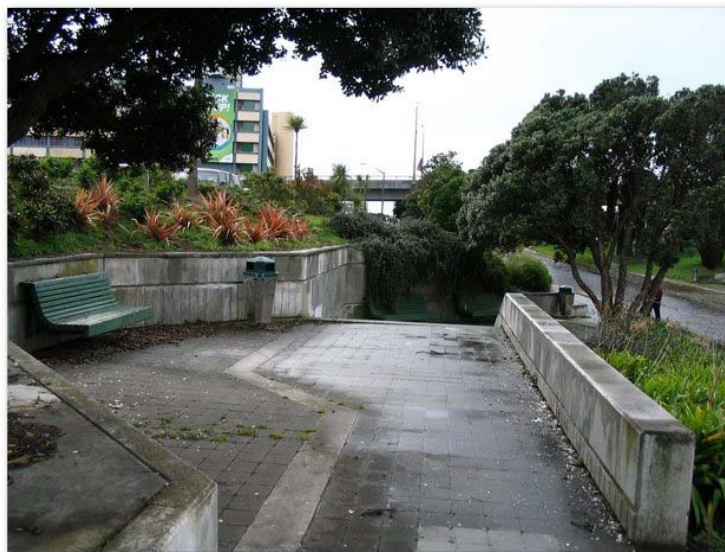
Figure 5 Flood wall incorporating seats and gardens

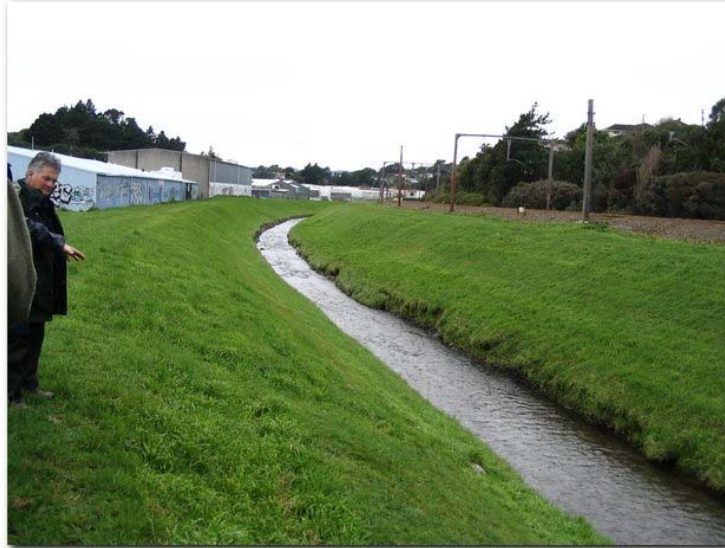
The stream at the end of Wall Place has mown grass banks and has a rock lining in sections. There was a small amount of frittering of the toe of the bank edge which was not seen as significant, particularly as the stream bed is fairly stable.

Figure 6 Looking down stream

The reviewers noted the well maintained stream banks in this reach. The grass cover was uniform and mown. The toe of the stream banks were frittering which will need to be monitored to ensure it does not develop to the point of causing problems.

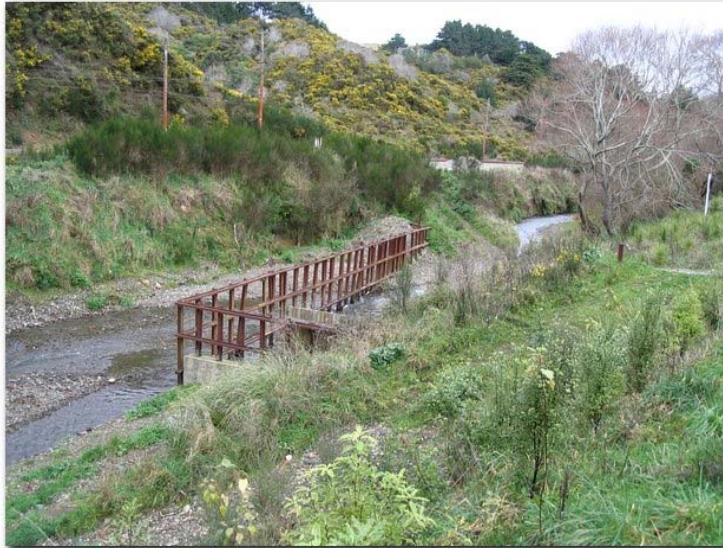
Figure 7 Debris arrestor looking upstream

The arrestor was in good condition and free of debris. A repair had been effected at the downstream end where it abutted to the left bank. It was also noted that the stream banks in the area had been planted with native plants by a local stream care group which will enhance the stream environment in time.

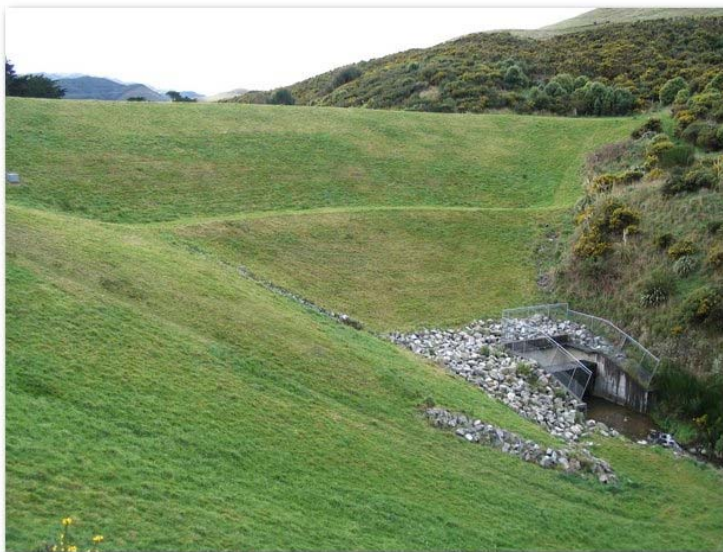
Figure 8 Down stream face of Stebbings dam

The reviewers note that a comprehensive monitoring and maintenance programme is in place for both dams and on site observation reinforced this. At Stebbing Dam there was an even sward of grass over the dam face which was well maintained with no significant unevenness in surface profile. The mowing of the grass was even considering the steepness of the dam walls. The intake structure at Seton Nossier was clear of debris and appeared to be well maintained.
