## **Report 01.508**

### **Waiwhetu Stream Sediment Investigation**

To inform the Committee of the results of investigations of contaminated sediments in the Waiwhetu Stream.

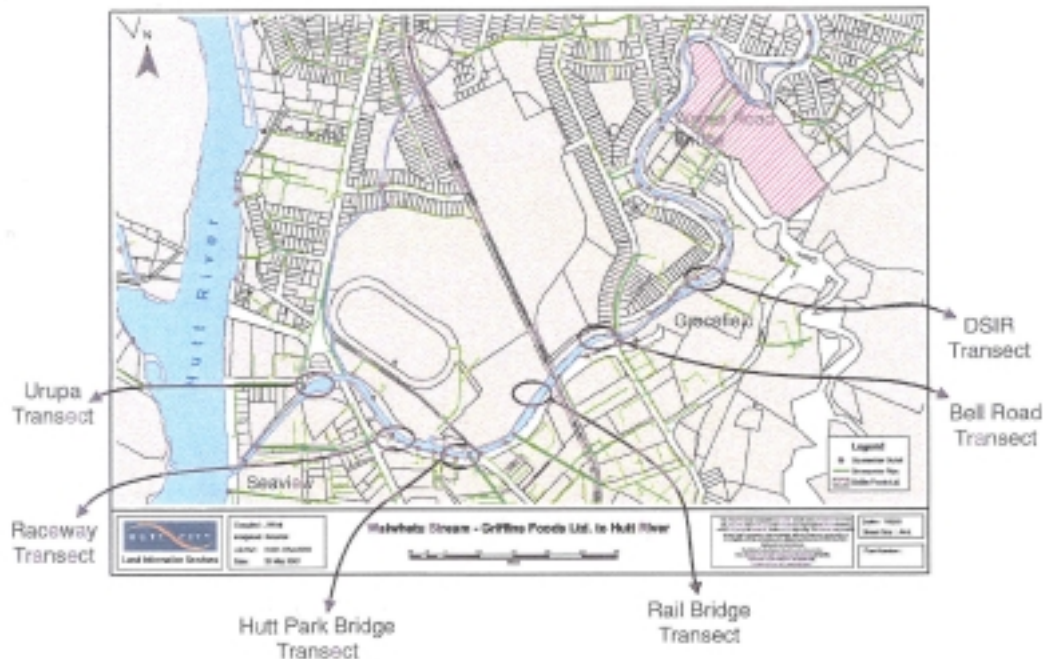
Twenty four sediment core samples were taken from six transects across the lower Waiwhetu Stream. These transects were located at the following sites:

- Mudflats just west of Seaview Road Bridge
- Adjacent to footbridge opposite the Hutt Park Raceway Grandstand
- South of the Hutt Park Road Bridge
- South of the Rail Bridge
- South of the Bell Road Bridge
- Opposite "E" Block at the Industrial Research Limited (IRL) site.

Figure 1: Waiwhetu Stream Study area – DSIR Transect to Urupa Transect. Base map provided by Hutt City Council includes major storm drain outlets.
