Te Kāuru Upper Ruamahanga River Floodplain Management Plan Subcommittee

Te Kāuru FMP – Proposed FMP endorsement and recommendation for public consultation

To seek endorsement of the proposed Te Kāuru Upper Ruamahanga Floodplain Management Plan (TKURFMP) from the Subcommittee and recommend the proposed Flood Management Plan (FMP) for public consultation.

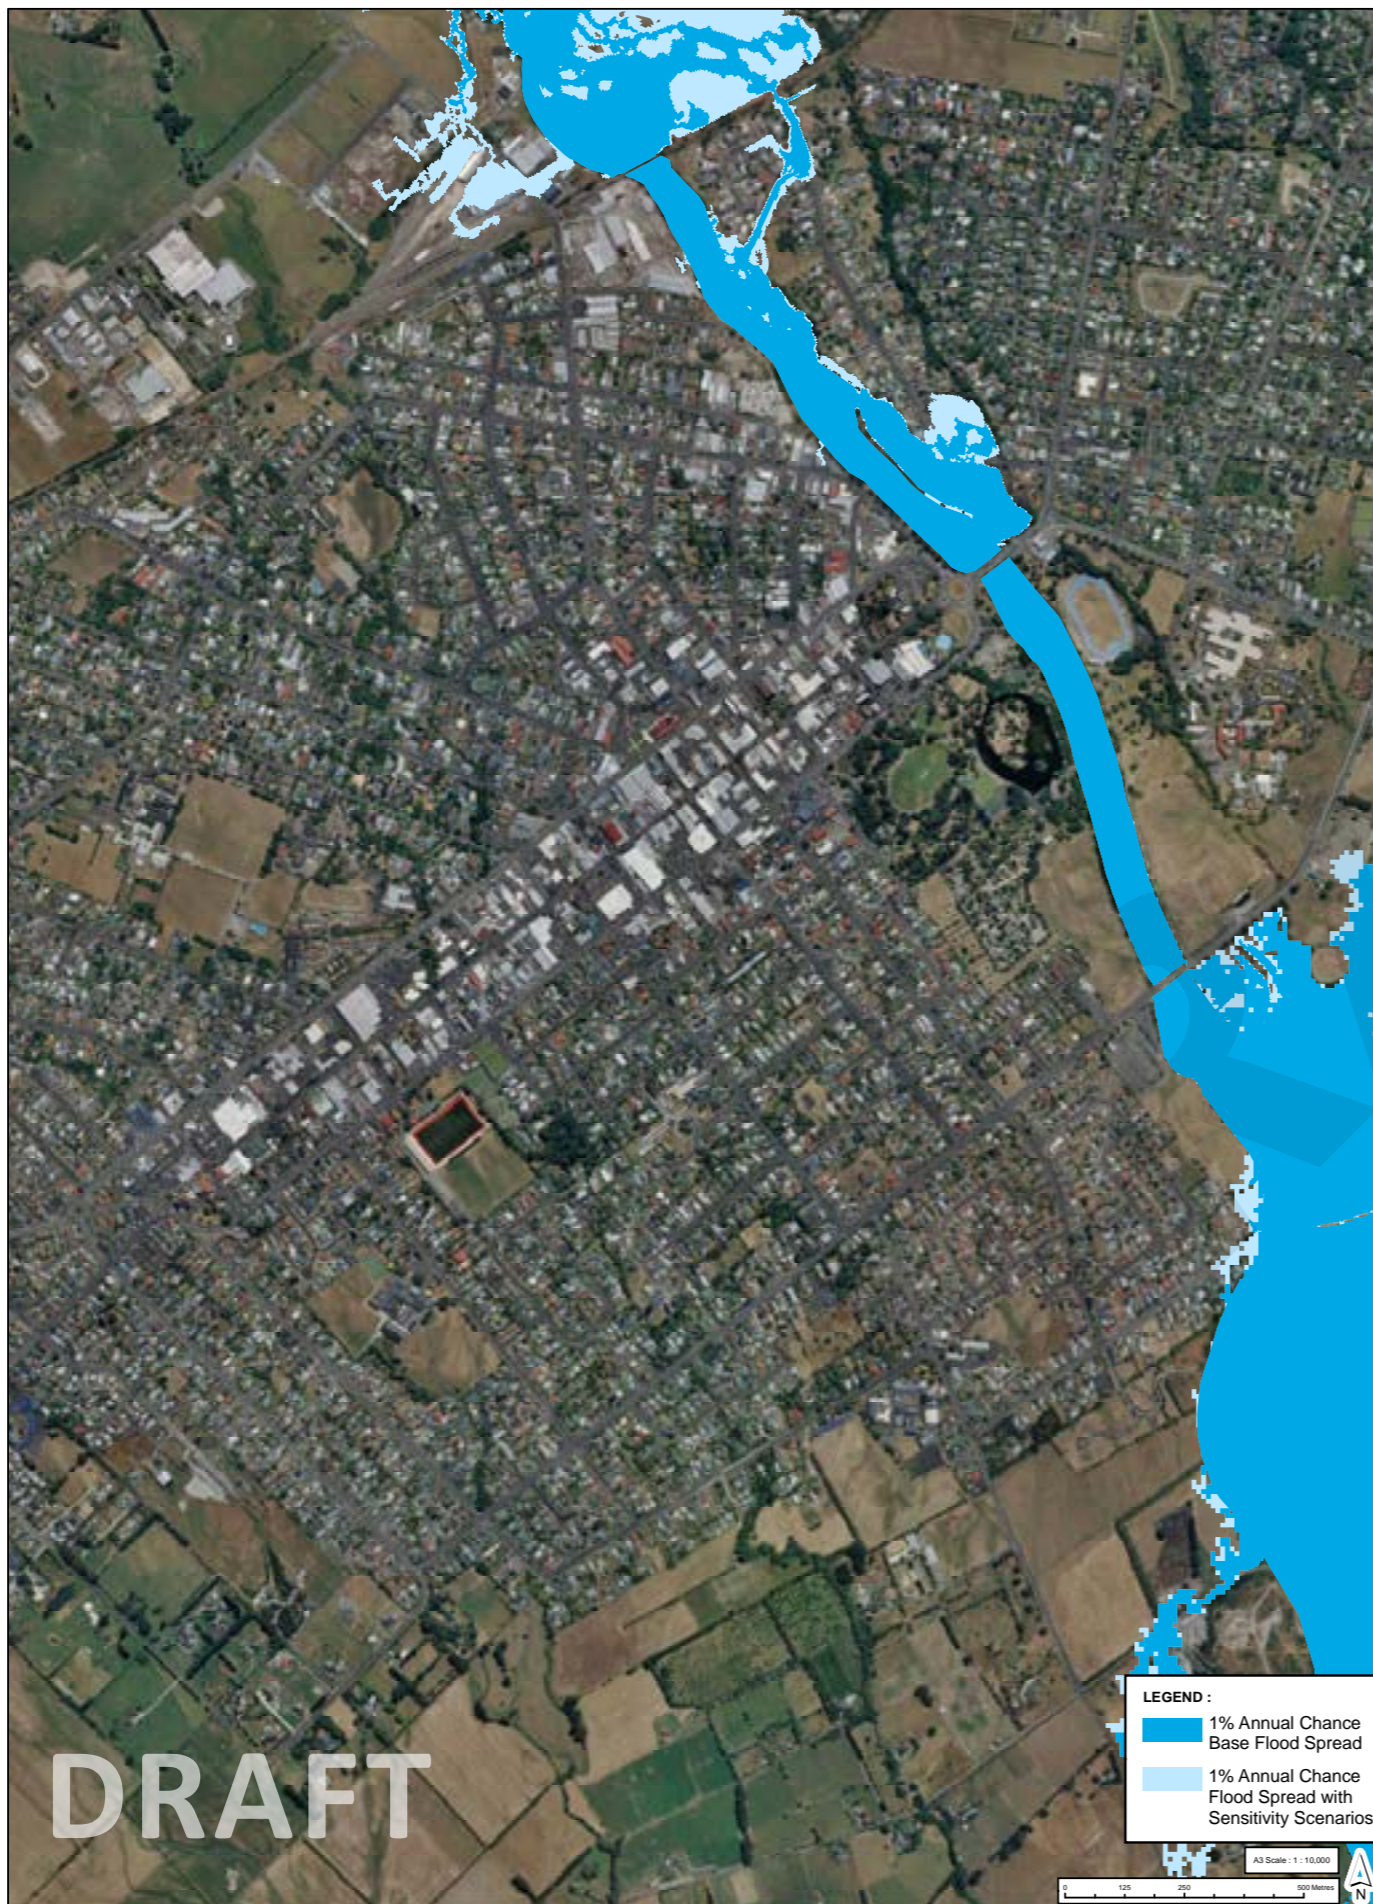
Waipoua River: DRAFT Current 1% Annual Chance Flood Spread with Sensitivity Scenarios and Base Flood Spread

Further downstream, flooding is also predicted to impact approximately 30 properties along River Road, at the confluence of the Waipoua and Ruamāhanga Rivers. Here the depths are predicted to be predominantly less than 0.4m.
